Document type	**Conservation record**
Identifier	RX0202300058 v0003
Creation date	3 September 2023
Last update	4 October 2023
Author	Cambridge Clocks Ltd (T. Jackson)
Title	RX0202300058 – Dent Regulator 42459
Description	Conservation summary for Dent Regulator N° 42459
Preceding Content Identifiers (CIDs)	n/a
Current CID (only applicable on pre-inscribed copies).	
Notes

Overhaul of Dent Regulator N° 42459 with jewelled palleted and zine-tube compensating pendulum completed by Brian Jackson September 02023

Report on
"DENT, LONDON"
Regulator.
N° 42459
(SPO 240)

Regulator, "DENT, LONDON"
N° 42459 SPO 240

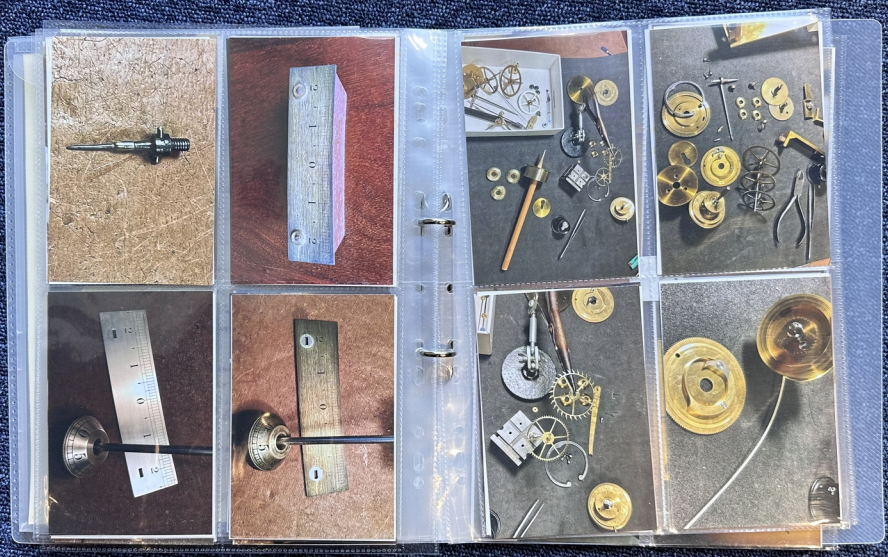
Spider in the case!
Minute-hand counter-balance
Fine pivot, compared to ordinary long-case clock pivot

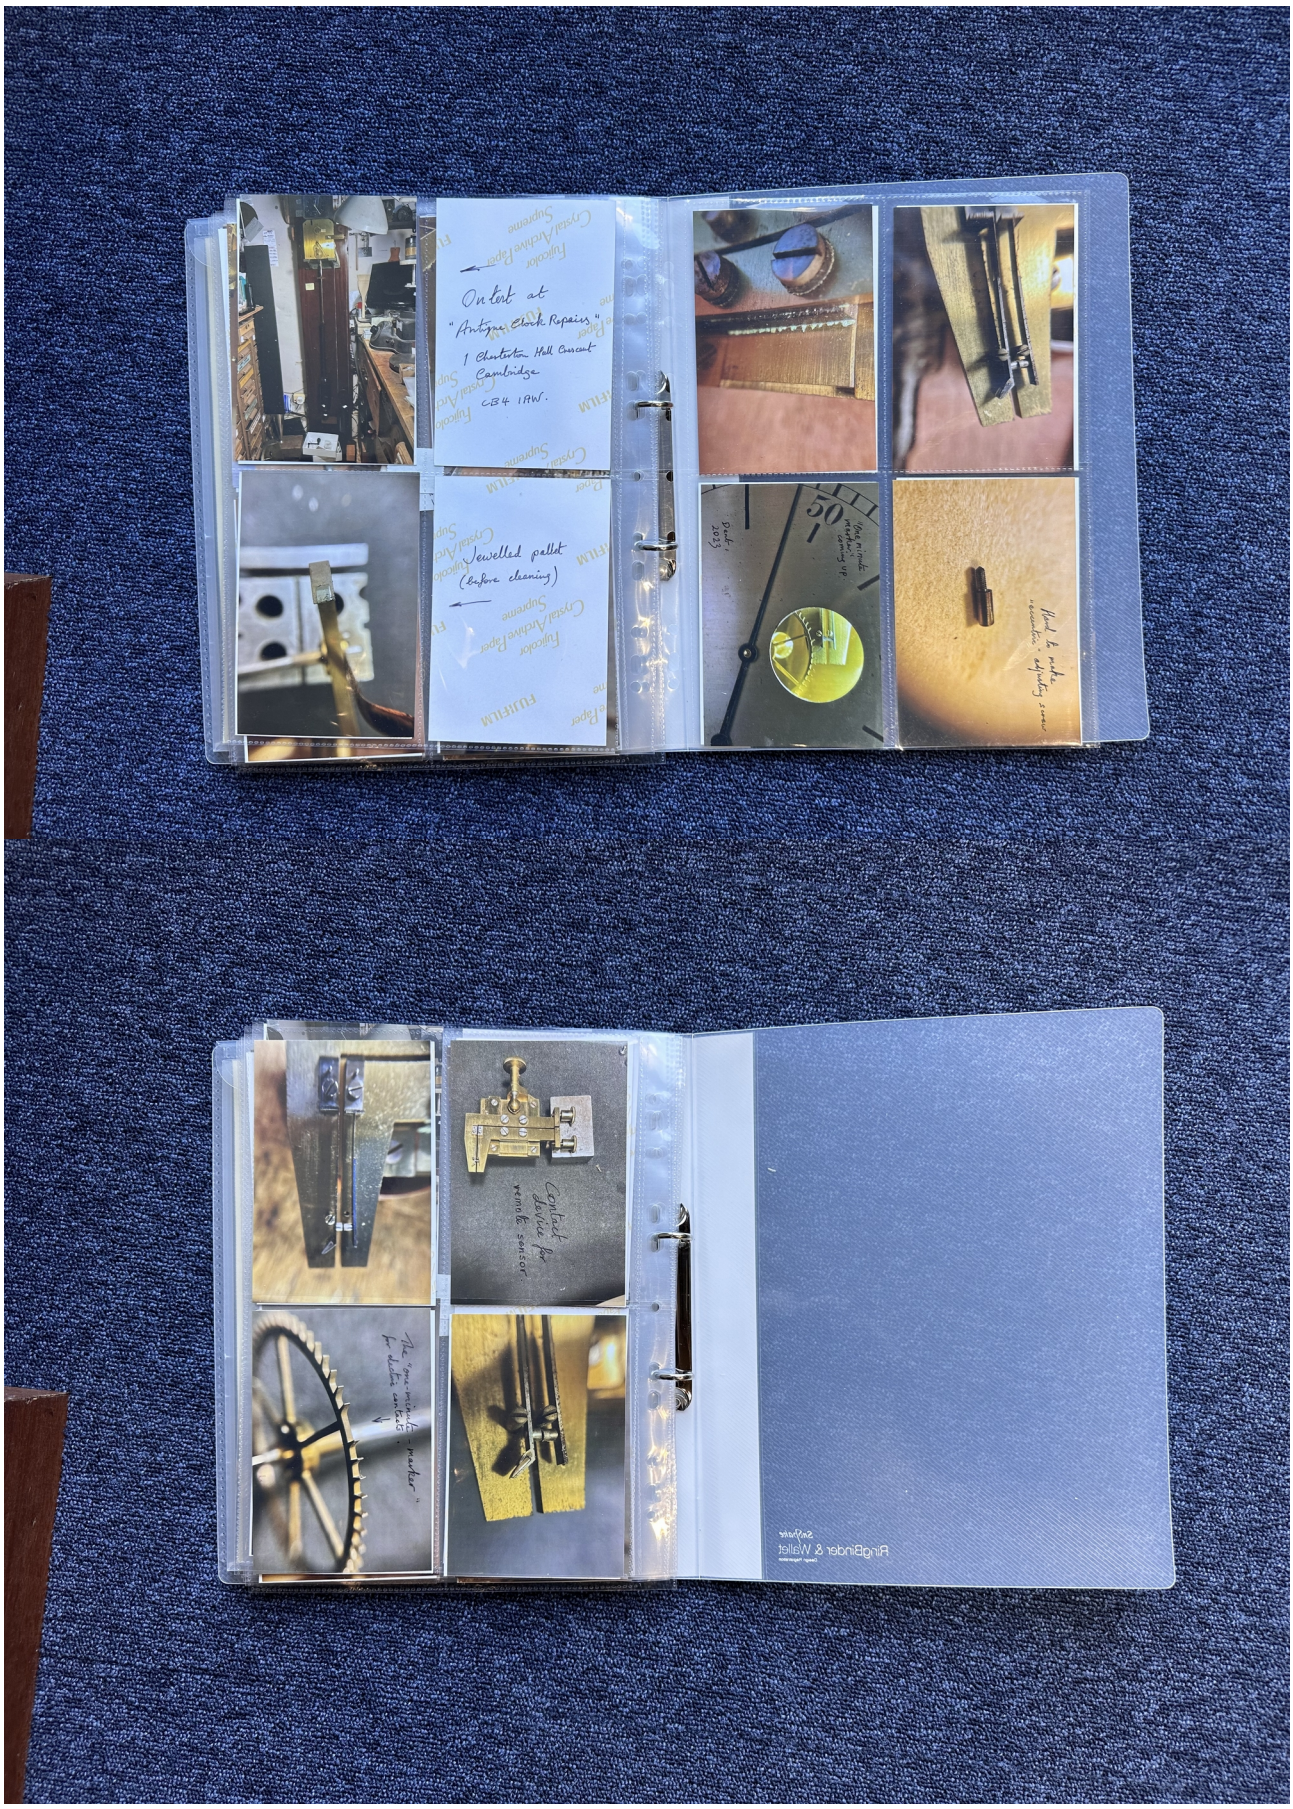
Too much
old oil !
